Expanded Site Inspection
Final Report

LoBue #2
South Chicago Heights, Illinois
ILD 980 902 050

August 9, 1995

Prepared for:
U.S. Environmental Protection Agency
under Alternative Remedial Contracting Strategy (ARCS)
Contract 68-W8-0064, Work Assignment 33-5JZZ
ARCS Contractor Project 71280.119

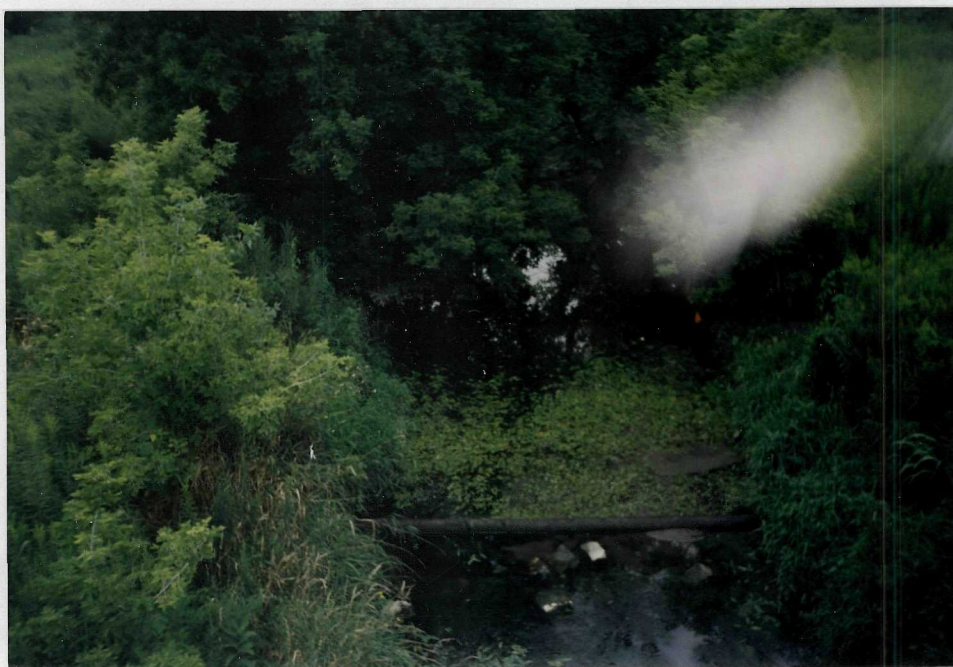
Description: Sediment sample ST02
location marked by red flag. Sample
collected from unnamed stream,
near a railroad culvert at the west
property line.

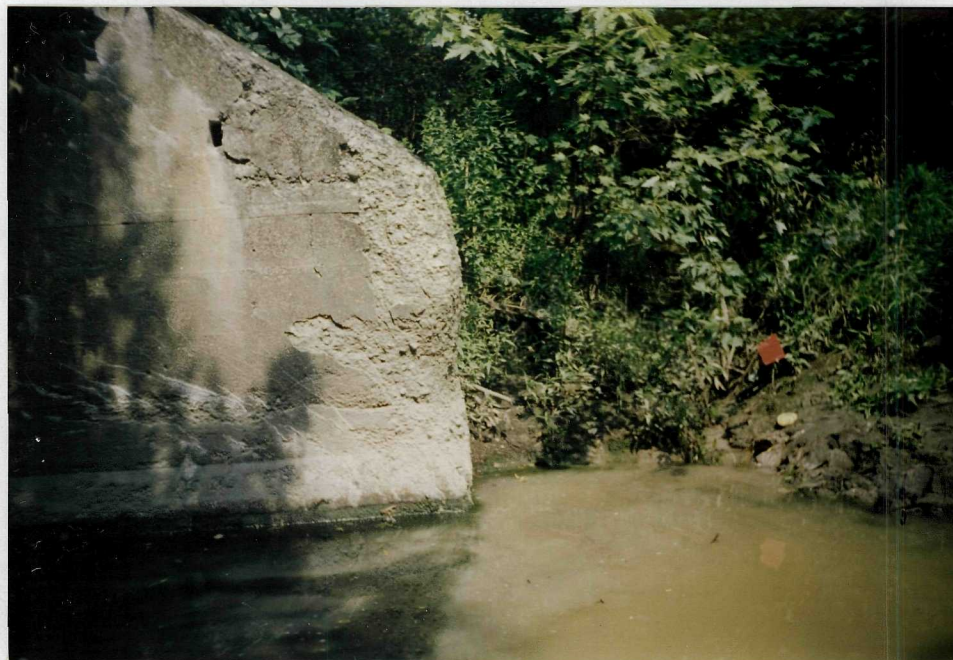
Description: Sediment sample ST03
location marked by red flag. Sample
collected from southwest bank of pond
#1, in the central portion of the site,
near soil, slag, and debris waste piles.

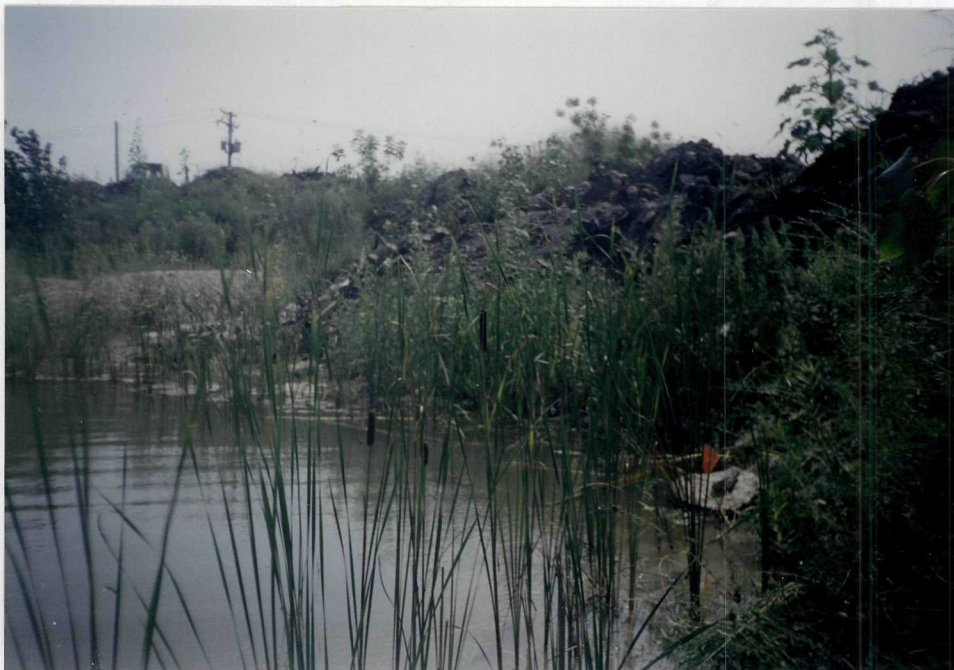
Description: Sediment sample ST04
location marked by red flag. Sample
collected from southern bank of pond
#2, in the southeast section of the site.
Exposed waste is visible along the
edge of the pond.

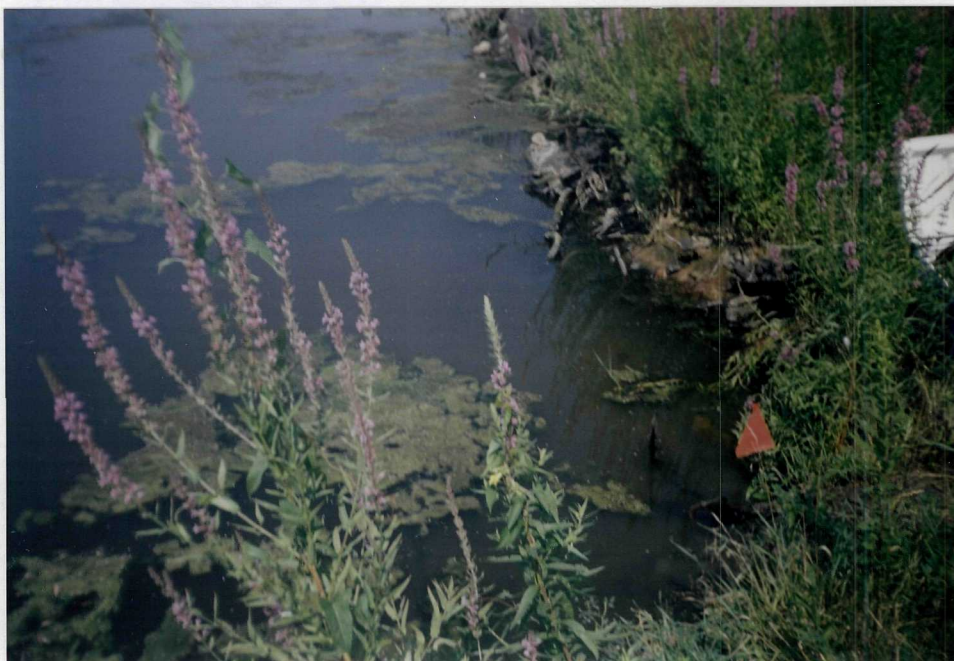
Description: Sediment sample ST08
location marked by red flag. Sample
collected from the east bank of eastern
perimeter drainage ditch.

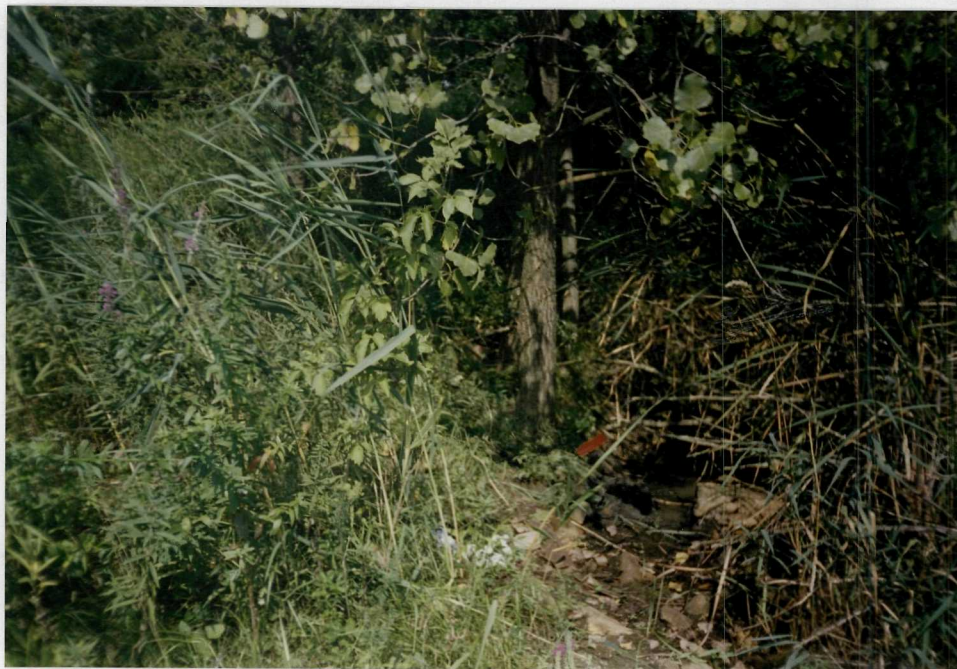
Description: Sediment sample ST05
location. Sample collected from south-
eastern edge of marsh, just left of the
stump, in the northeast section of the
site. Standing water in marsh.

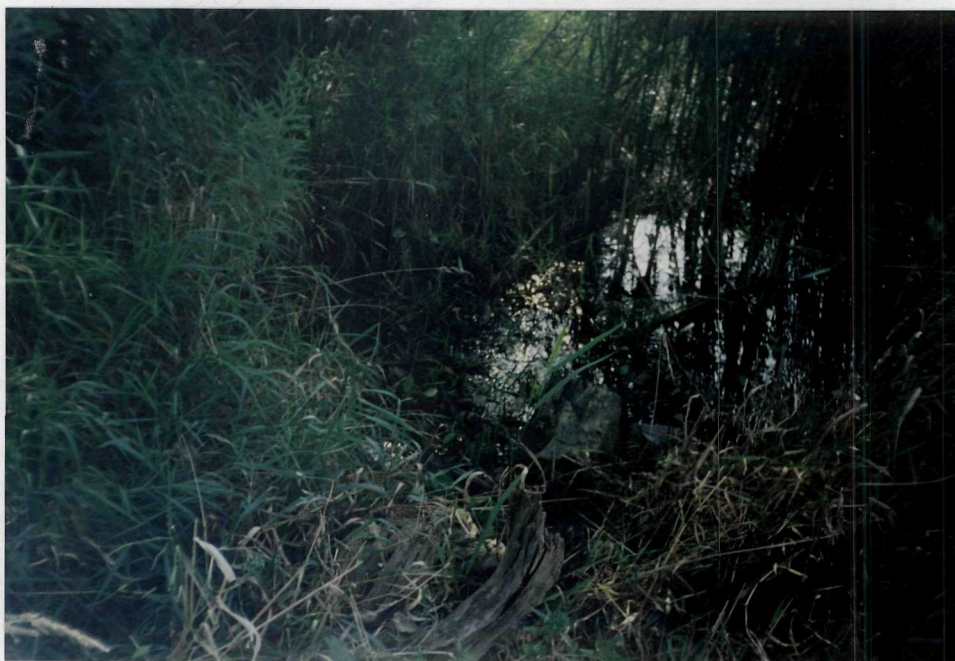
Description: Sediment sample ST06
location marked by upright sampling
spoon. Collected from northwestern
edge of the marsh, in the northeast
section of the site.

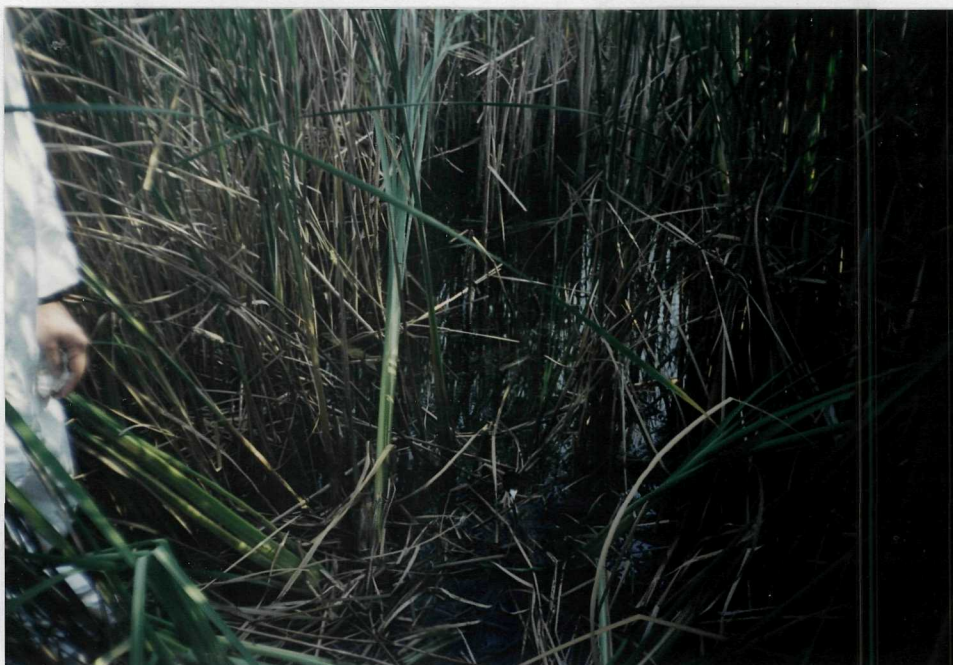
Description: Sediment sample ST07
location marked by upright sampling
spoon. Sample collected near the
sediment/water interface from the
south bank of the northern perimeter
drainage ditch.

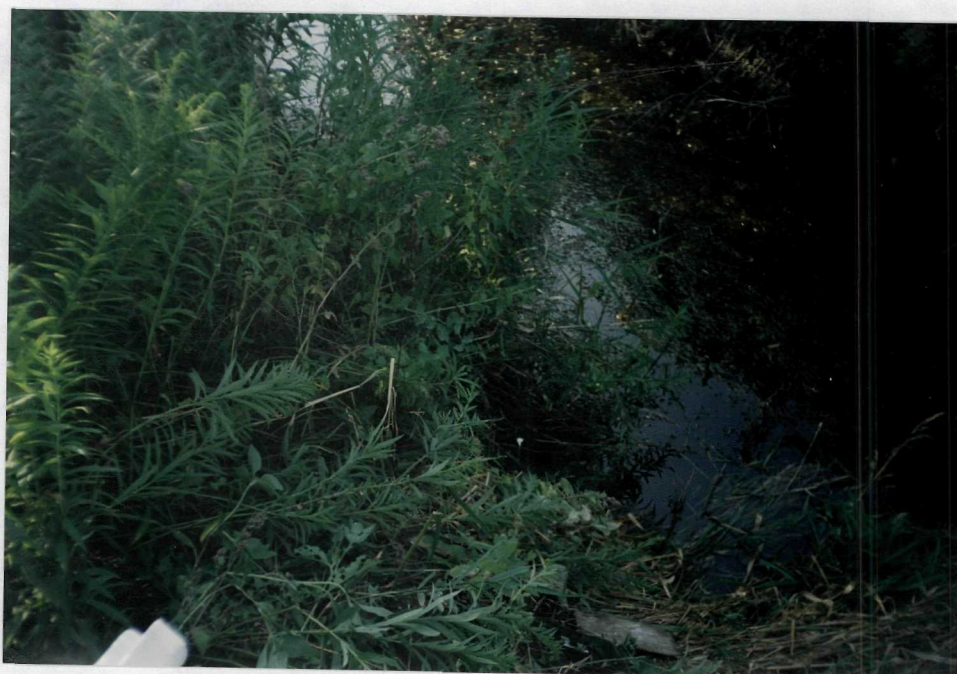
Description: Soil sample SS04
location marked up upright sampling
spoon. Sample collected near the
southwest corner of site, adjacent to
the southwestern edge of waste pile E.

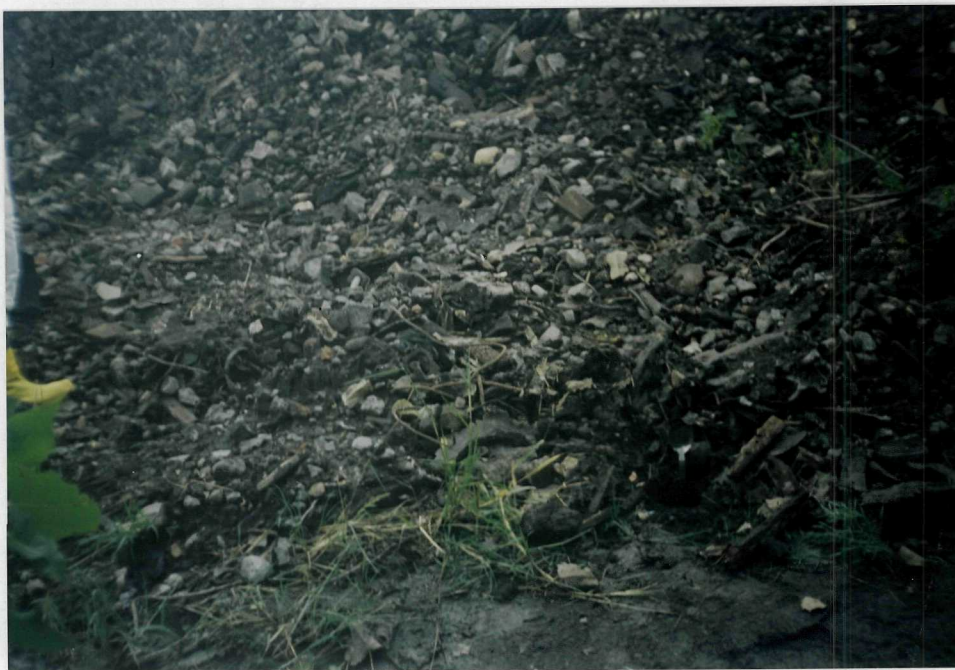
Description: Soil sample SS03
location marked by upright sampling
spoon. Sample collected in the south-
west section of site, adjacent to the
western edge of waste pile F.

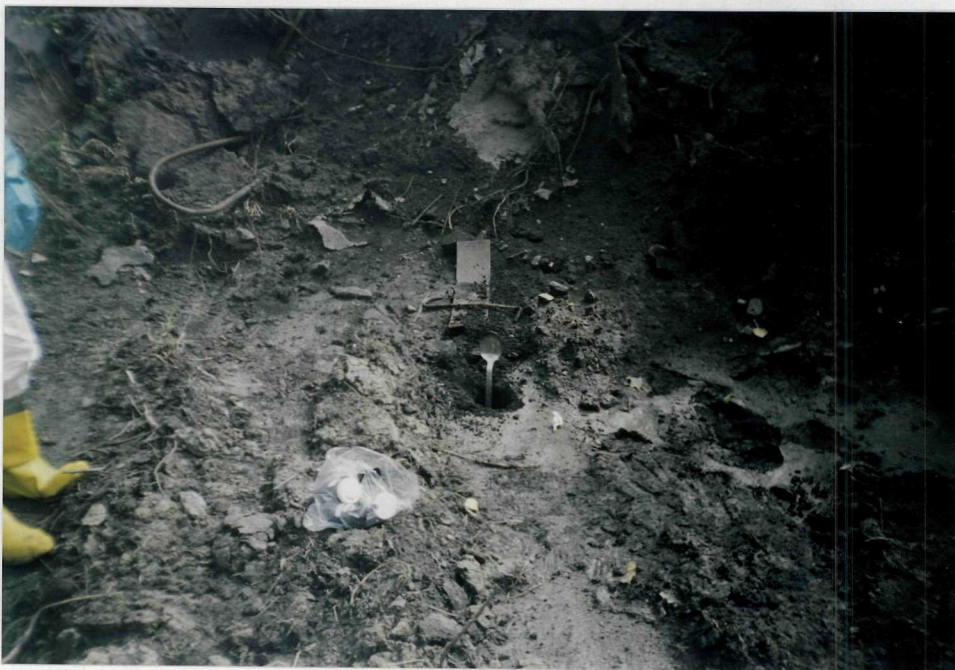
Description: Soil sample SS05
location marked by sampling spoon.
Sample collected just west of pond
#1, adjacent to edge of waste pile S.

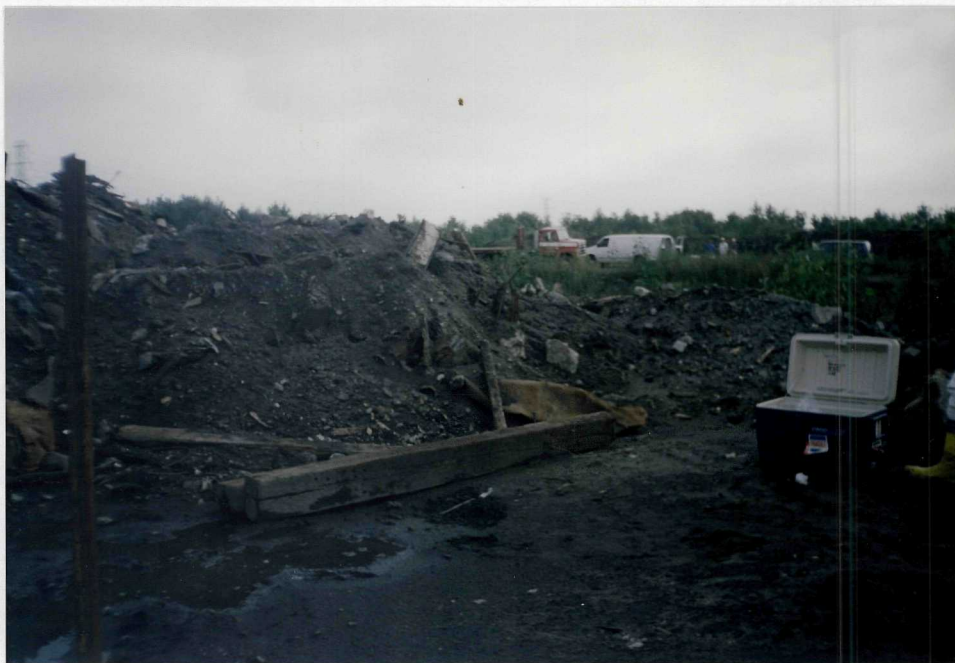
Description: Soil sample SS09
location marked by sample containers.
Sample collected near east side of
pond #2, about 100 feet north of
Sauk Trail Road.

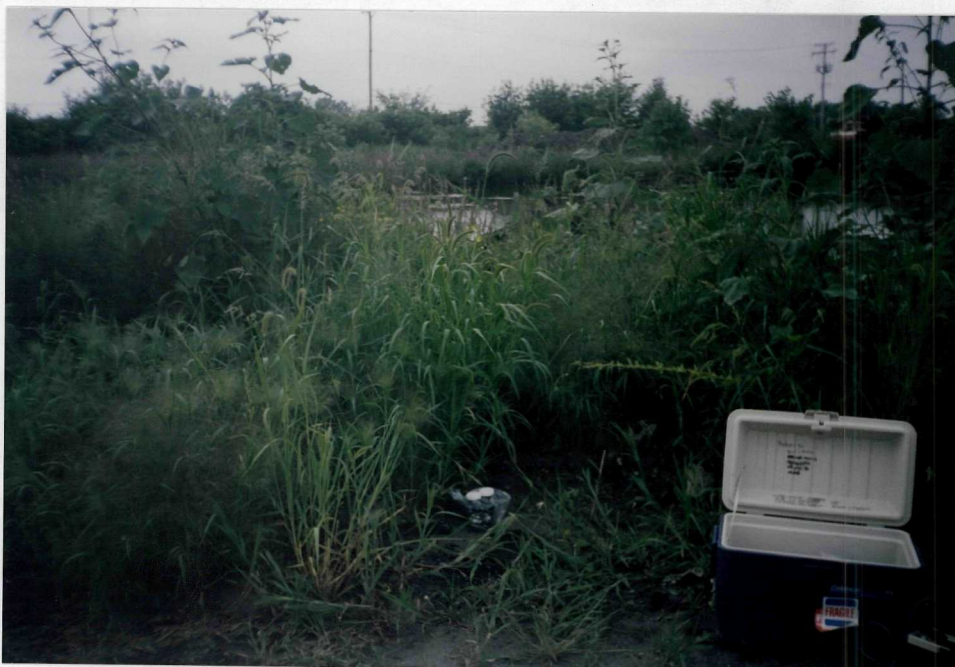
Description: Soil sample SS08
location marked by upright sampling
spoon. Sample collected adjacent to
northwestern edge of waste pile R.

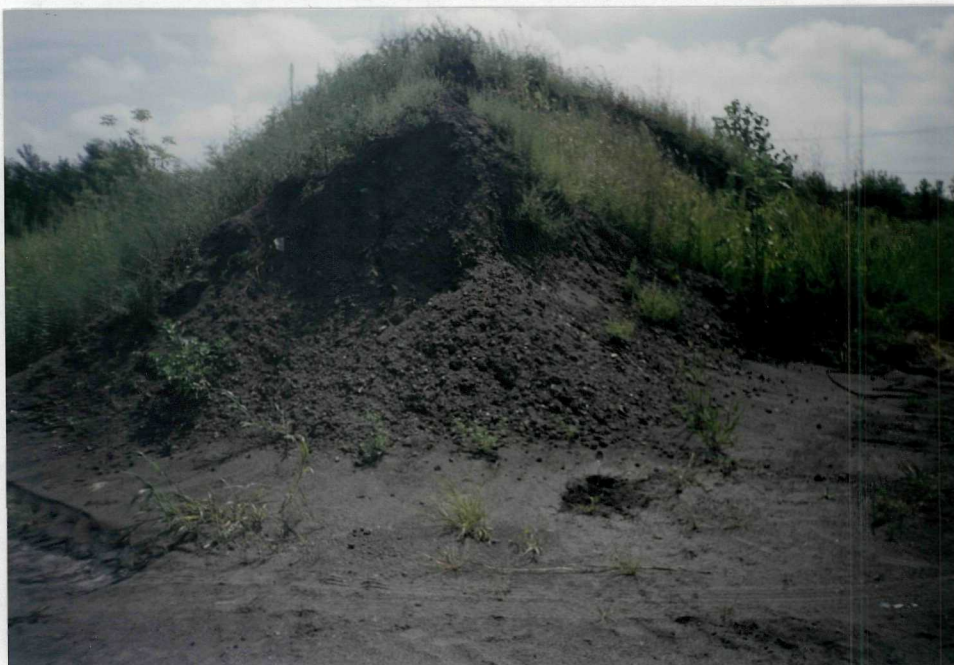
Description: Soil sample SS06
location marked by upright sampling
spoon. Collected about 150 feet
south of the northern perimeter
ditch, north of scattered waste pile
K, in the north-central portion of
the site.

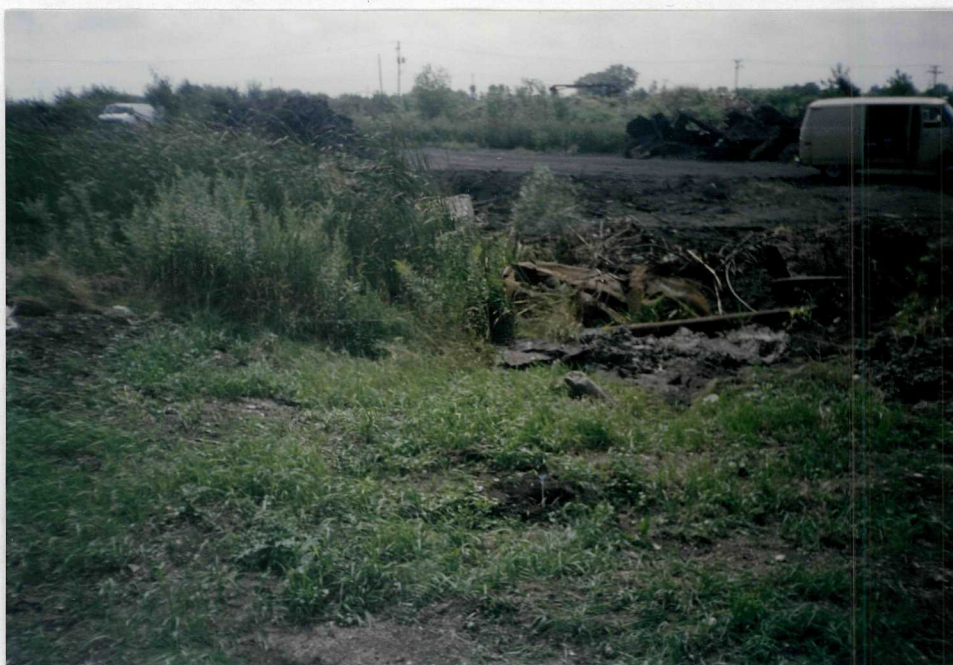
Waste sample WS01 was collected from the solidified tar-like material (waste pile H) in the northwestern section of the site. The sample had to be broken into small pieces with a hammer before being containerized. Sample WS02 was collected from the large black ash waste pile (waste pile G) in the northwestern section of the site. Sample WS03 was collected from the soil, slag, rebar, concrete and brick fragments, and debris waste pile (waste pile D) in the southwestern section of the

Description: Soil sample WS01
location. Sample collected from
waste pile H (black tar-like waste),
northwest of tanks visible in the
background.

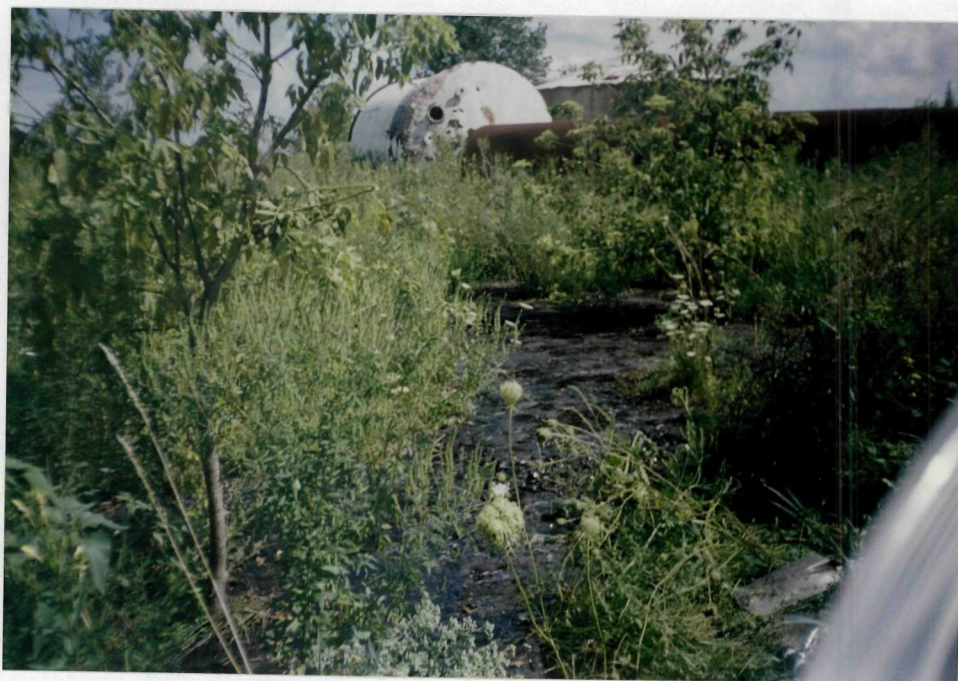
Description: Soil sample SS02
location marked by upright sampling
spoon. Sample collected about 6
feet northwest (downgradient) of
waste pile H, in the northwest section
of the site.

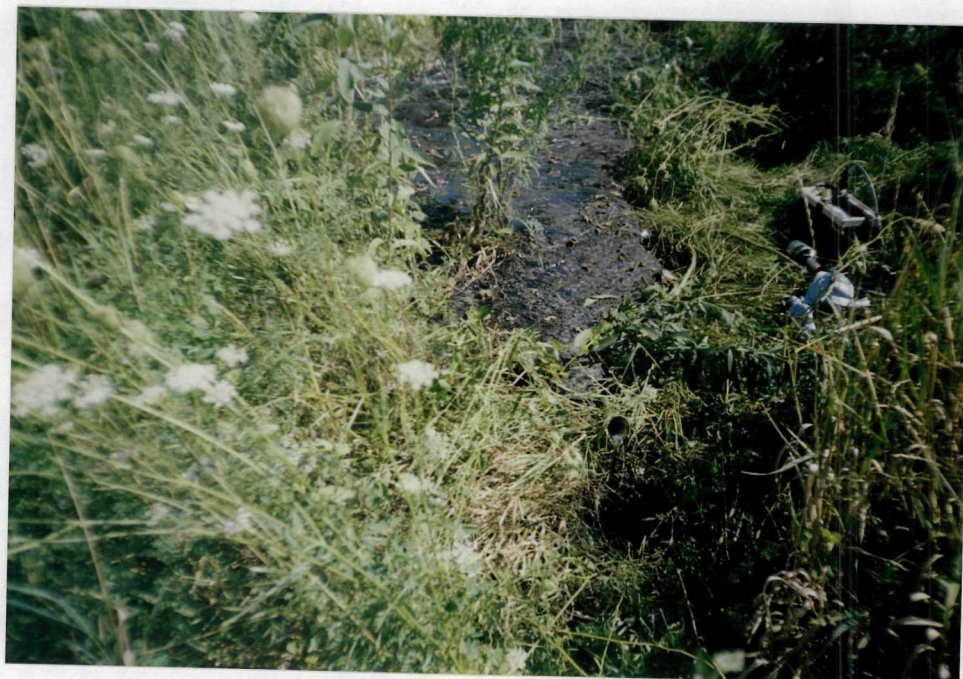
Four ESI waste samples (WS02 through WS05) were collected for waste piles believed to contain foundry wastes. Sample WS02 was collected from the large black ash waste pile (waste pile G) in the northwestern section of the site. The black ash waste pile is approximately 20 feet high and 300 feet in diameter. Sample WS03 was collected from the soil, slag, rebar, concrete and brick fragments, and debris waste pile (waste pile D) in the southwestern section of the site. The waste pile had been graded by the scrap metal salvaging contractor working onsite before and during the ESI sampling visit, but soil, slag, iron pieces, and concrete and brick fragments were still evident in the graded pile. Sample WS04 was collected from the foundry sand waste pile (waste pile I) in the northwestern section of the site. Waste pile I is approximately 6 feet high and 25 feet in diameter. The last sample, WS05, was collected from the grey slag, crushed scrap metal, and concrete debris waste pile (waste pile Q) in the eastern section of the site. Waste pile Q is approximately 15 feet high and 30 feet in diameter.

Description: Waste sample WS02
location marked by red flag. Sample
collected from waste pile G (black
ash waste) in the northwest section
of the site.

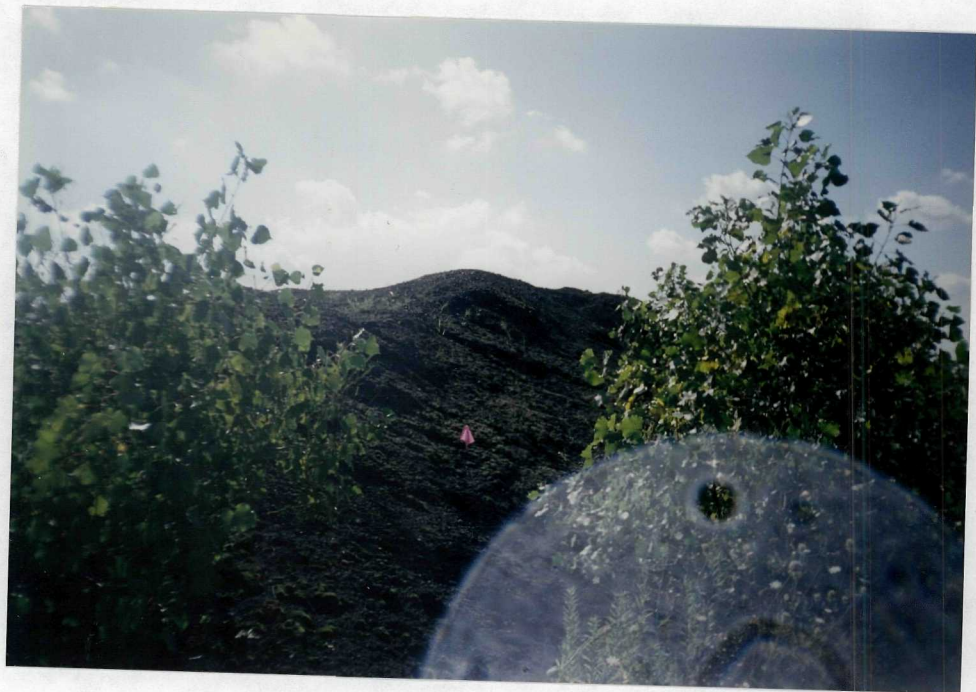
A background soil sample, SS01, was collected from the northern perimeter berm that runs along the northern property line. This location was selected as representative of natural soil conditions in the area. Other soil samples were collected from locations adjacent to onsite waste piles. Sample SS02 was collected approximately 6 feet northwest (downgradient) of waste pile H in the northwestern section of the site. Samples SS03 and SS04 were collected adjacent to waste piles F and E, respectively, in the southwestern section of the site. Sample SS05 was collected adjacent to waste pile S, west of pond 1. Sample SS06 was collected north of scattered waste pile K in the north-central portion of the site. Sample SS07 was to be collected adjacent to three crushed drums encountered during the reconnaissance visit, north of the marsh; however, the sample was not collected because the drums could not be located in the heavy, tall vegetation. Sample SS08 was collected adjacent to waste pile R in the eastern portion of the site. Sample SS09 was to be collected adjacent to a scrap metal waste pile partially in pond 2. However, the waste pile had been removed, and part of pond 2 had been filled in by

Description: Soil sample SS01
location marked by sample containers
in plastic bag. Sample collected from
south side of berm along the northern
property line, about 50 feet south of
power lines, near center of the
property line.

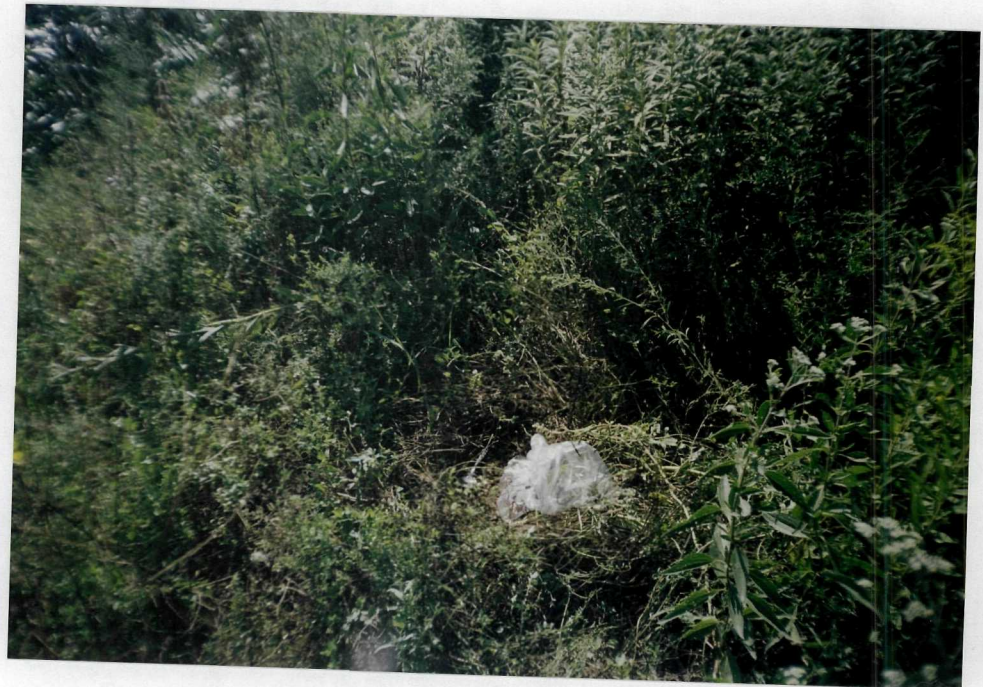
Description: Waste sample WS05
location. Sample collected from waste
pile Q (grey slag with scrap metal and
concrete debris) in the eastern
section of the site.

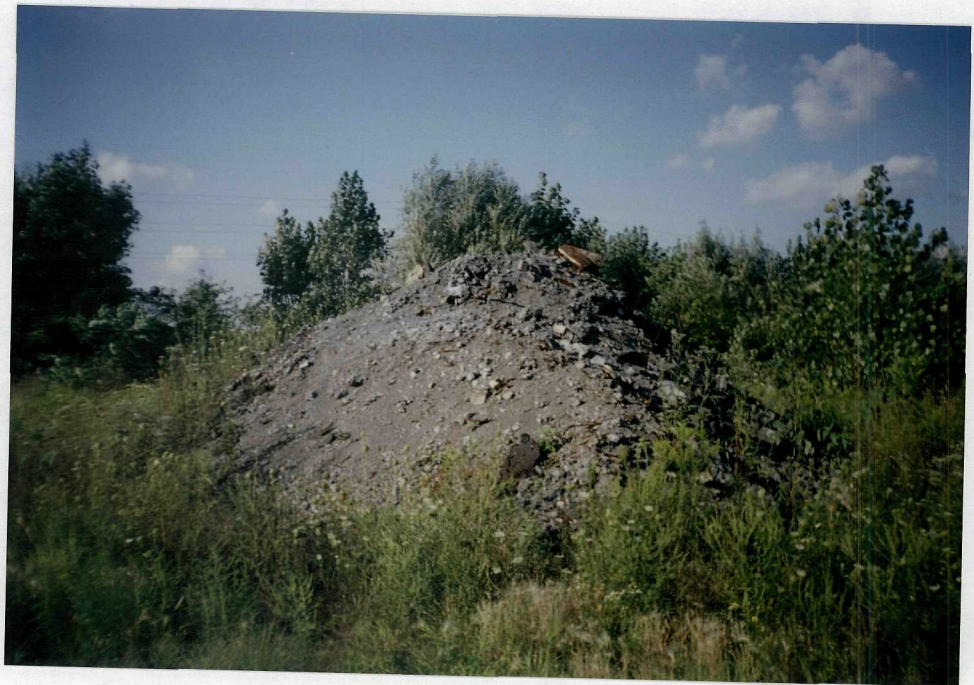
Description: Waste sample WS04
location. Sample collected from waste
pile I (foundry sand) in the northwest
section of the site.

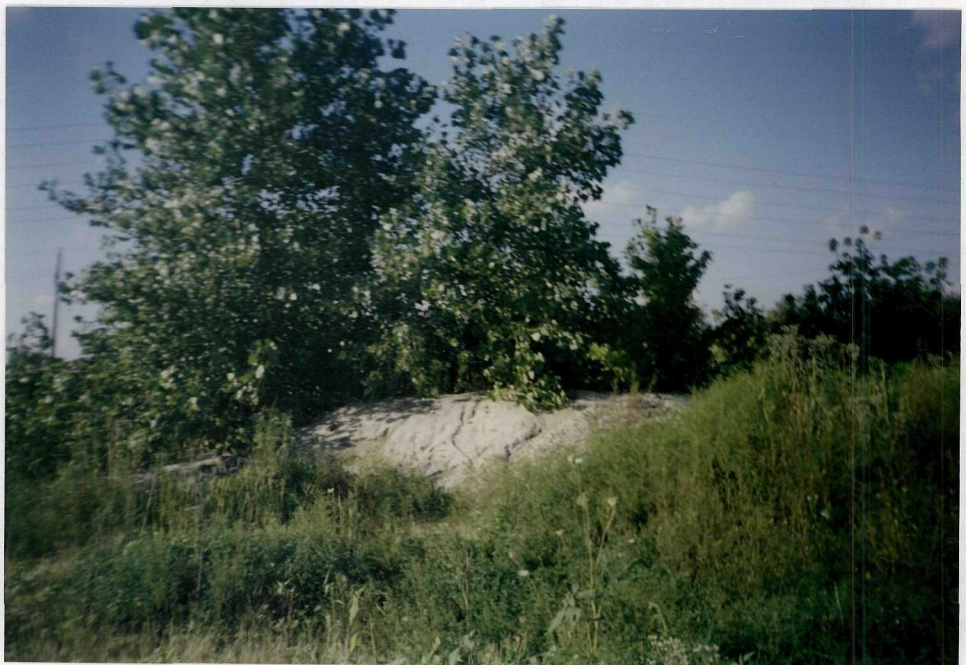
Description: Waste sample WS03
location. Sample collected just left
of the large concrete chunk, from
graded waste pile D in the southwest
section of the site.

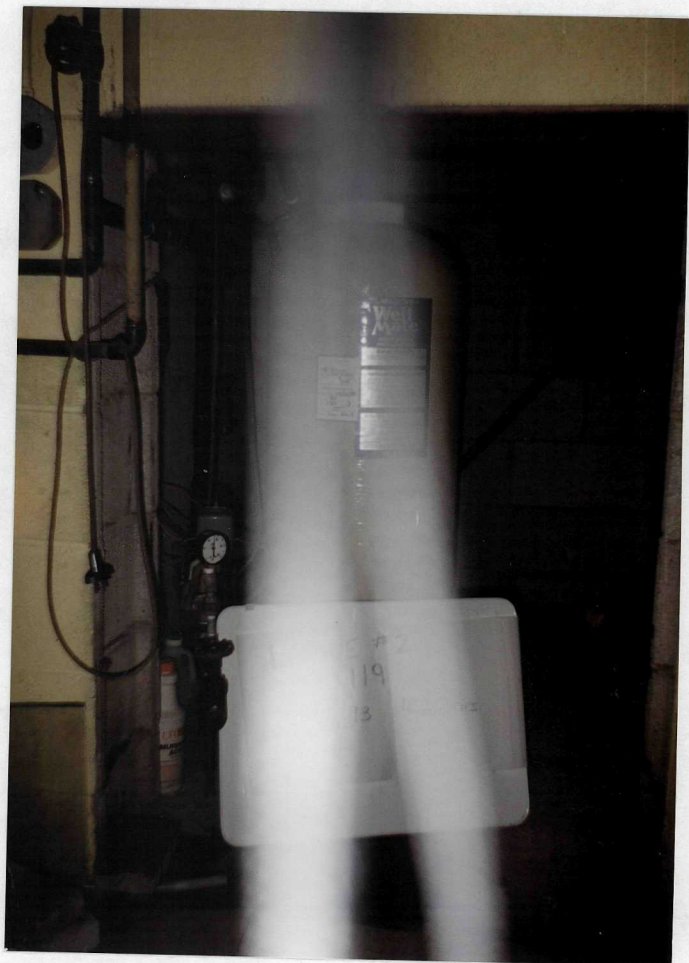
Description: Close-up view of
labels on the water system pressure
tank for residential well RW01.

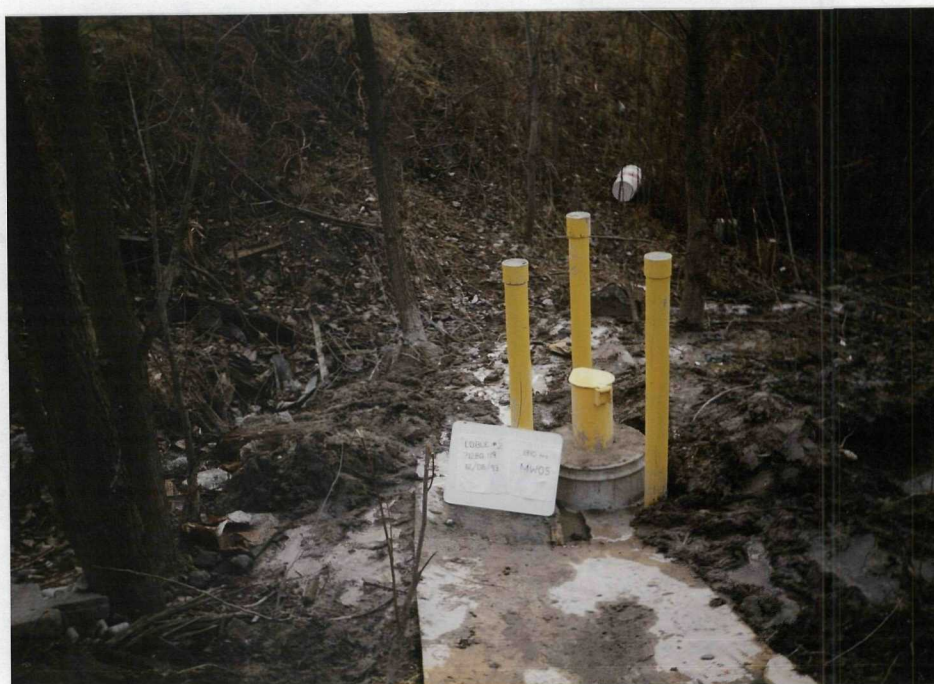
Description: Monitoring well
MW06 location, near the west
property line.

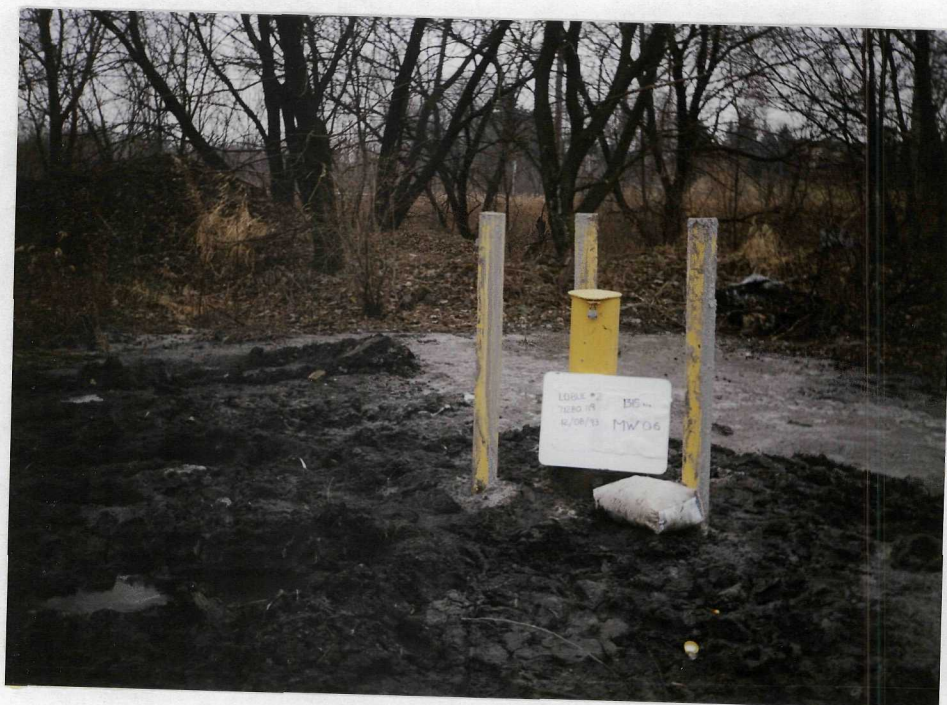
Description: Monitoring well
MW07 location, near the southern
property line, northeast of the
entrance gate.

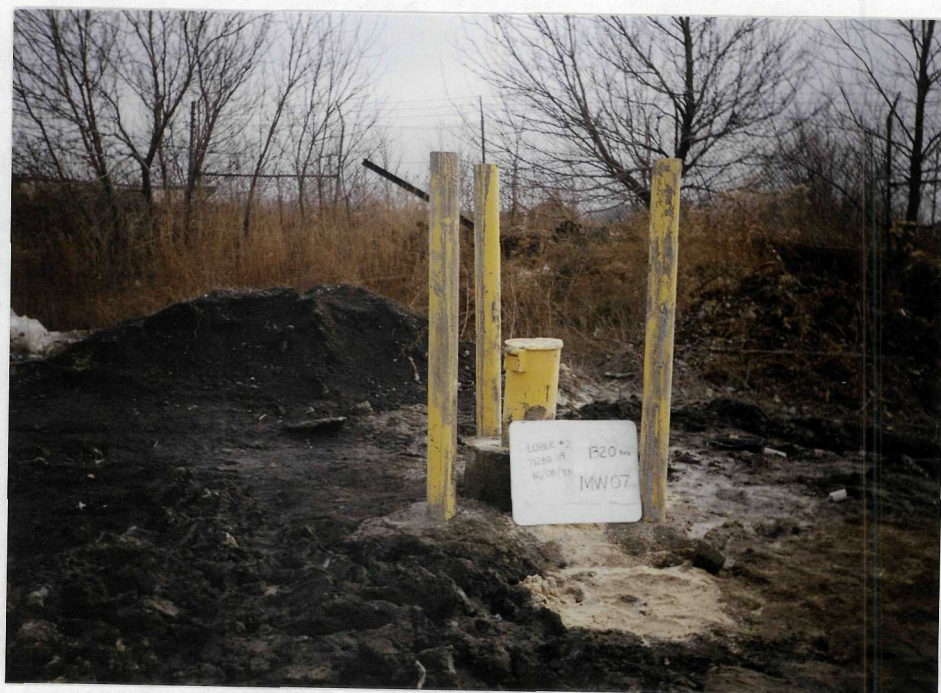
Description: Monitoring well
MW08 location in the southeast
section of the site.

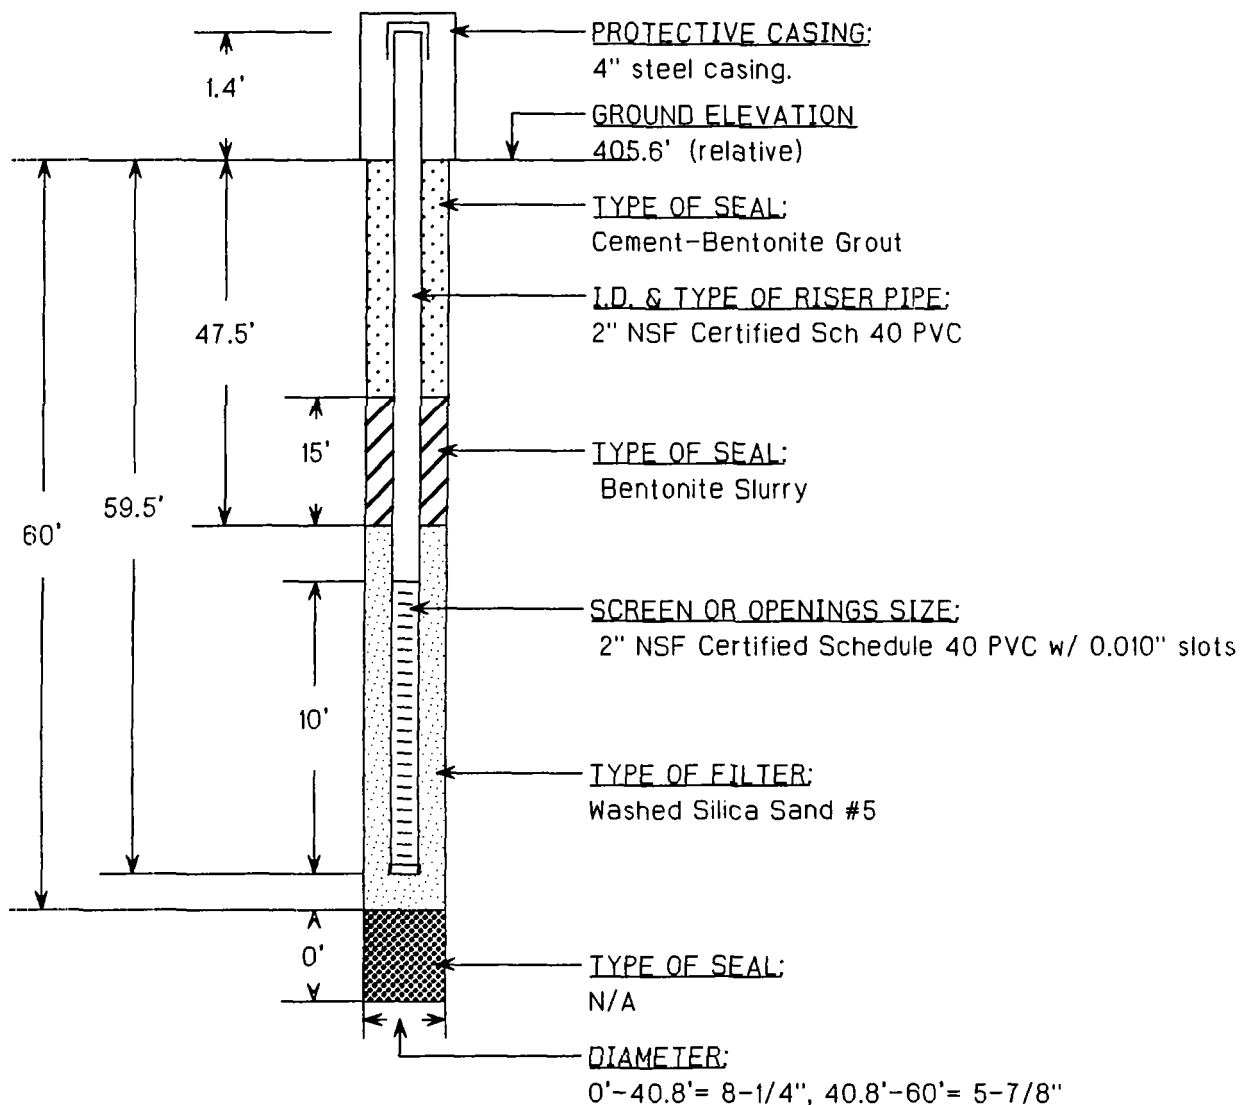
NO. MW05

Boring drilled to completion. Set riser pipe and screen. Placed filter and seal. Grouted to 2' below ground surface. Set above ground protective steel casing. Concrete surface seal placed 4" above ground surface.

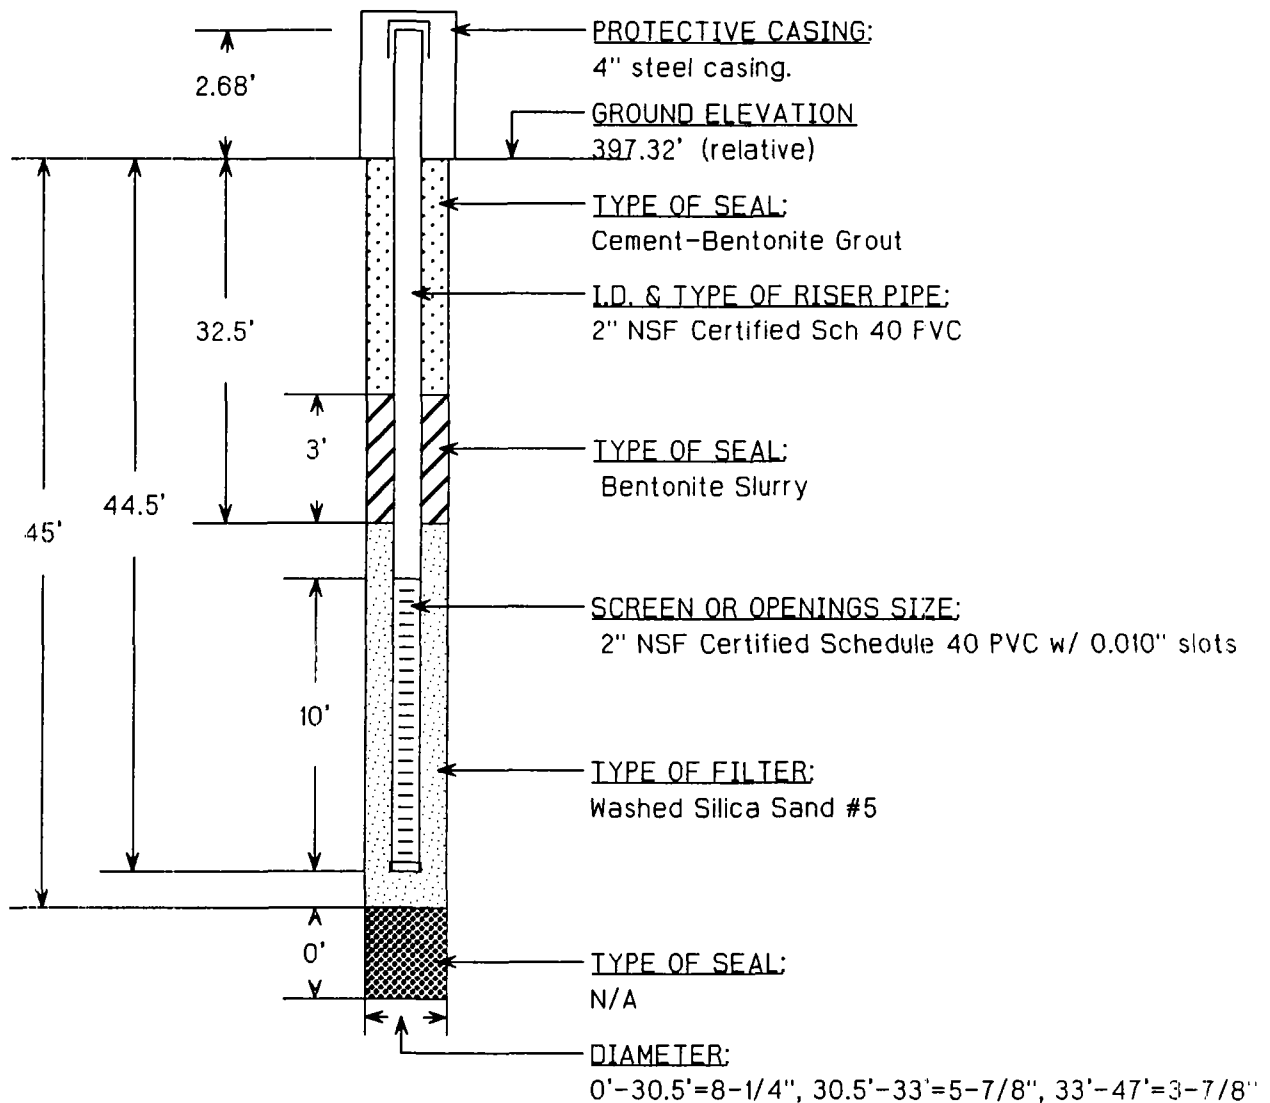
NO. MW08

Boring drilled to completion. Set riser pipe and screen. Placed filter and seal. Grouted to 2' below ground surface. Set above ground protective steel casing. Concrete surface seal placed 4" above ground surface.

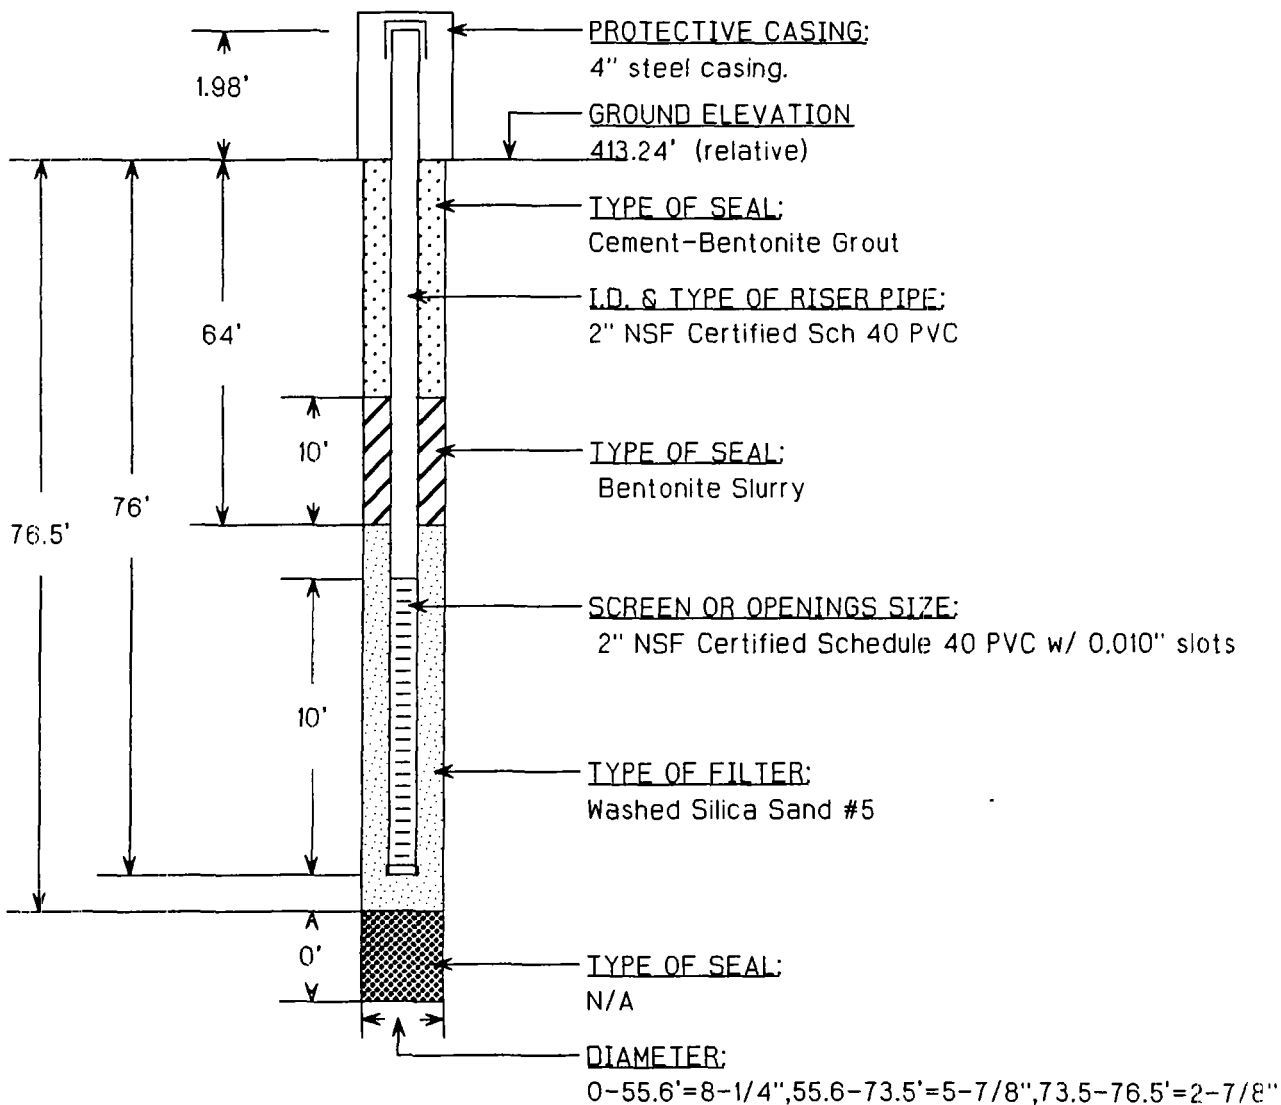
NO. MW07

Boring drilled to completion. Set riser pipe and screen. Placed filter and seal. Grouted to 2' below ground surface. Set above ground protective steel casing. Concrete surface seal placed 4" above ground surface.

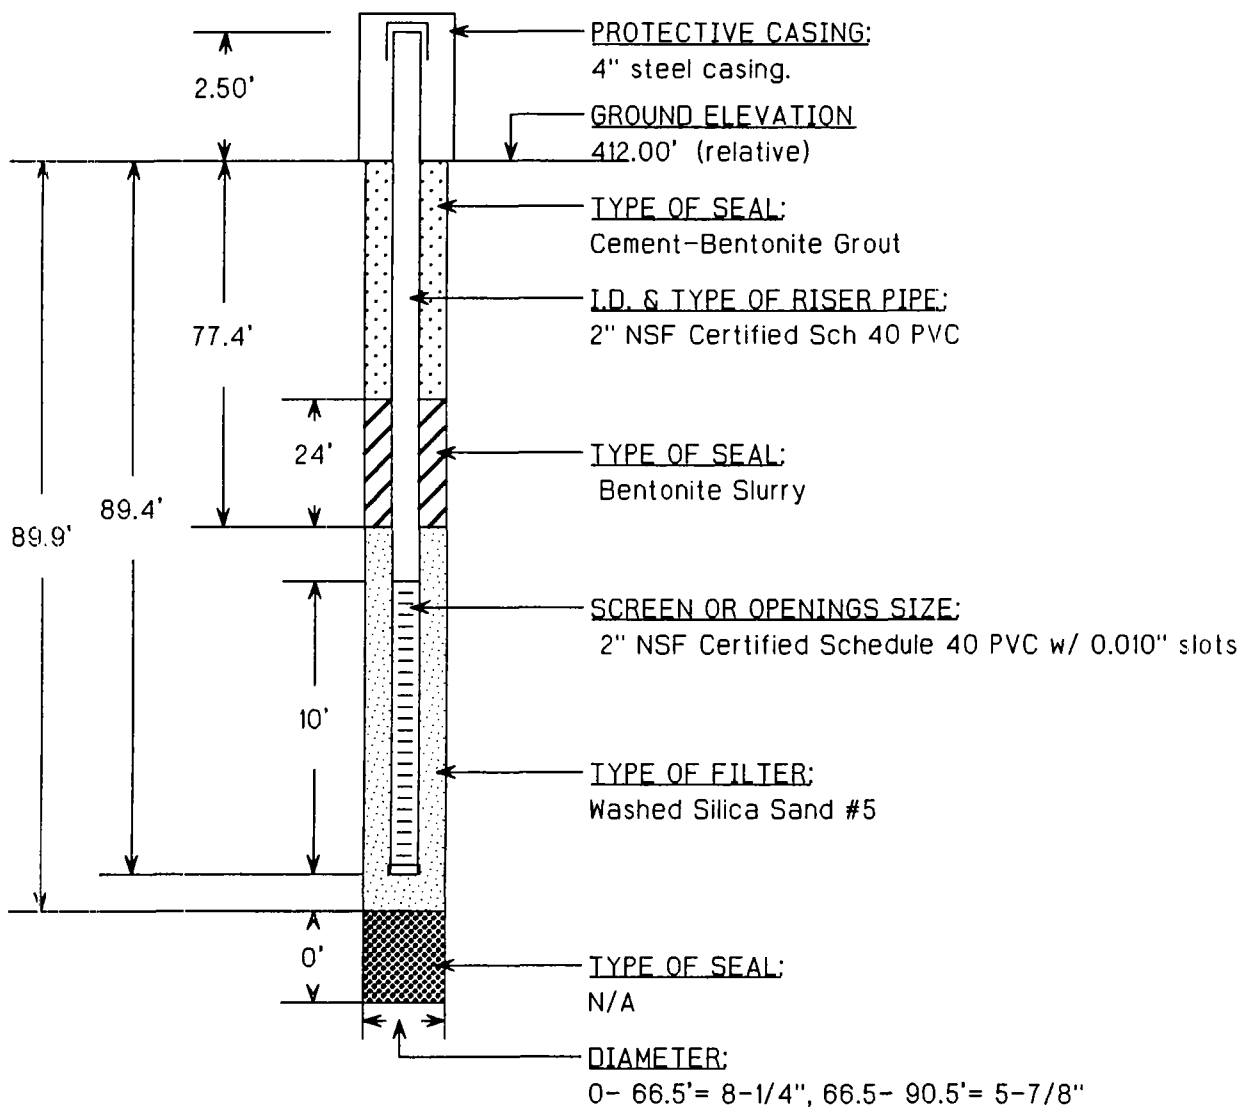
WELL INSTALLATION LOG

Boring drilled to completion. Set riser pipe and screen. Placed filter and seal. Grouted to 2' below ground surface. Set above ground protective steel casing. Concrete surface seal placed 4" above ground surface.
